Contract #: 04-0120F4Cty: SF/ALA Rte: 80 PM: 13.2/13.9File #: 13.28**WELDING INSPECTION REPORT****Resident Engineer:**Pursell, Gary**Address:** 333 Burma Road**City:** Oakland, CA 94607**Report No:** WIR-008522**Date Inspected:** 14-Aug-2009**Project Name:** SAS Superstructure**OSM Arrival Time:** 700**Prime Contractor:** American Bridge/Fluor Enterprises, a JV**OSM Departure Time:** 1530**Contractor:** Oregon Iron Works Clackamas, Or.**Location:** Clackamas, OR**CWI Name:** Mike Gregson, Jose Salazar**CWI Present:** Yes No**Inspected CWI report:** Yes No N/A**Rod Oven in Use:** Yes No N/A**Electrode to specification:** Yes No N/A**Weld Procedures Followed:** Yes No N/A**Qualified Welders:** Yes No N/A**Verified Joint Fit-up:** Yes No N/A**Approved Drawings:** Yes No N/A**Approved WPS:** Yes No N/A**Delayed / Cancelled:** Yes No N/A**Bridge No:** 34-0006**Component:** Hinge K Pipe Beams**Summary of Items Observed:**

Hinge-K Pipe Beam Assembly 102A-1: 8/14/09

WELDING INSPECTION REPORT

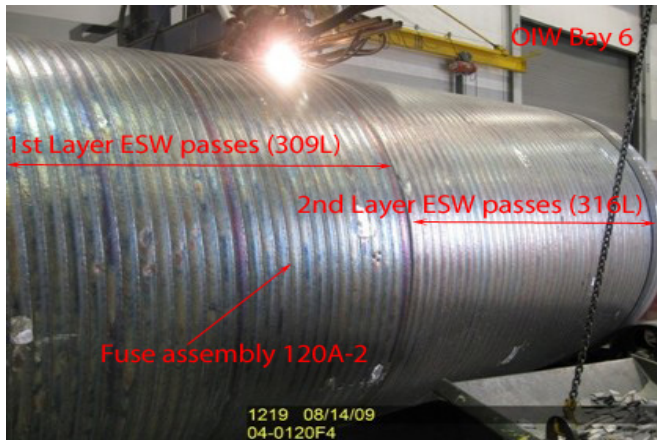
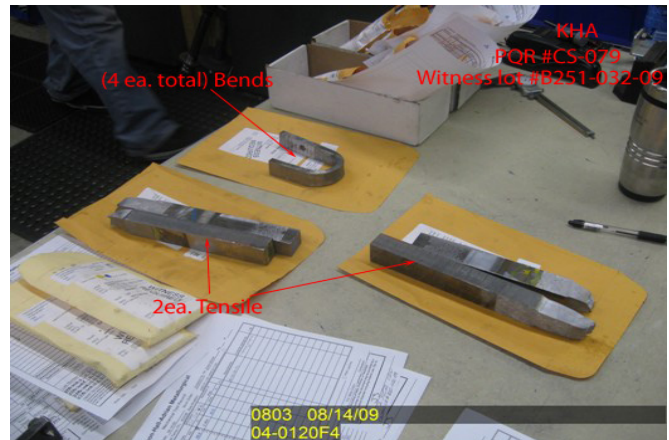
QA Inspector noticed that the ESW stainless steel overlay passes were in-process, on this fuse assembly 120A-2. QA Inspector witnessed welder #F17, Mr. Igor Frolov performing electro slag welding (ESW) on the second layer welding passes, (approximately 50% complete), in the flat position, utilizing Soudokay brand Soudotape 316L stainless steel consumable strip. QA Inspector noted the first layer passes were previously completed utilizing the 309L consumable strip, per contract requirements. QA Inspector randomly noticed QC Inspector's Mike Gregson and Jose Salazar were present, to verify in-process welding parameters (amps/volts) and monitor in-process continuous pre-heat temperatures. QA Inspector spoke with QC Inspector Jose Salazar and Mr. Salazar explained that welding amps were recorded as 1200 amps/25 volts, travel speed at 279mm/min. and a pre-heat temperature recorded at 70 degrees Fahrenheit (20 C). QA Inspector verified Mr. Igor Frolov was currently qualified for this welding process/position and randomly recorded pre-heat temperatures of approximately 70 degrees Fahrenheit. QA Inspector noted that Mr. Igor Frolov appeared to be in compliance with the applicable approved welding procedure specification (WPS 7003). See attached picture below.

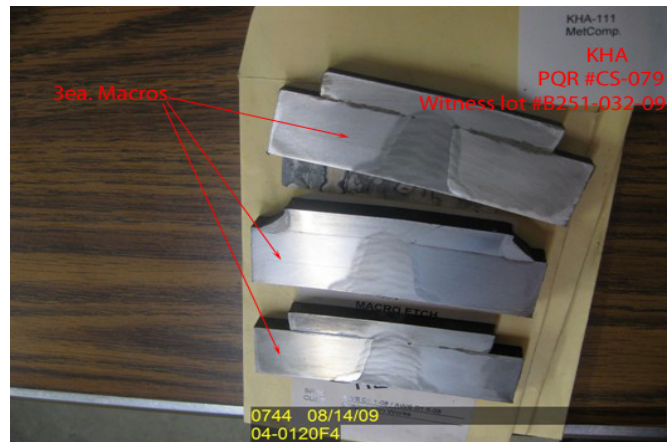
QA Inspector witnessed KH perform the macro, bend, charpy, tensile tests and KH explained to QA Inspector that the macro, bend, charpy and tensile tests, for the PQR CS-079, were in compliance with AWS D1.5. QA Inspector performed visual testing on the macroetch and guided bend samples and noted that these samples had no visible discontinuities; including cracks, lack of fusion, slag and porosity. QA Inspector noted that these samples appeared to be in compliance with AWS D1.5. QA Inspector was provided with all applicable testing reports and completed the applicable welding witness report (TL6032), on this date. See attached pictures below.
